HISTORIC PROPERTY INVENTORY FORM

Field Site No. 2614-E-2 **OAHP No.** _____ **Date Recorded** 20 Aug 1996
Site Name Historic General Monitoring Station **Revised** 15 July 1997
Common Air Monitor Station
Field Recorder M.S. Gerber
Owner's Name U.S. Department of Energy, Richland Operations Office
Address P.O. Box 550
City/State/Zip Code Richland, WA 99352

HISTORIC PROPERTY INVENTORY FORM
Building 2614-E-2 (Continuation Sheet 1 of 1)

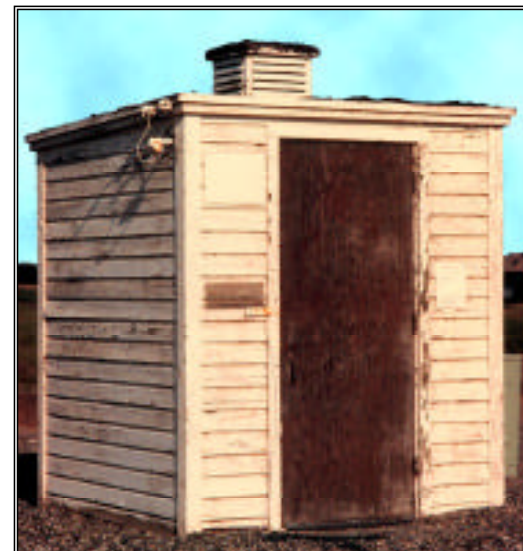
Photo at right: 96080189-23
Looking east

The 2614-E-2 Building is a single room, 6.75 foot square, wood frame building clad with horizontal drop siding. The building has a shed roof with built up felt roofing and an insulated asbestos board ceiling. There is a 16 inch square, raised ventilator covered with louvers in the center of the roof. The building sits on an eight inch thick, poured concrete foundation. There is one pedestrian door and no windows. Pumps and monitoring equipment were placed the station, such that air was drawn through filter samplers and then checked and recorded when technicians visited the building and brought the filter papers into laboratories for analysis. A gamma monitoring device was placed in the louvered cupola on the building's roof. The facility was heated with an electric heater until it was been abandoned in the early 1960s.
